Nº 166 Service Bulletin

DATE: September 20, 2006

SUBJ: Grand Prix / NASCAR®
Trough Up-Kicker Failure

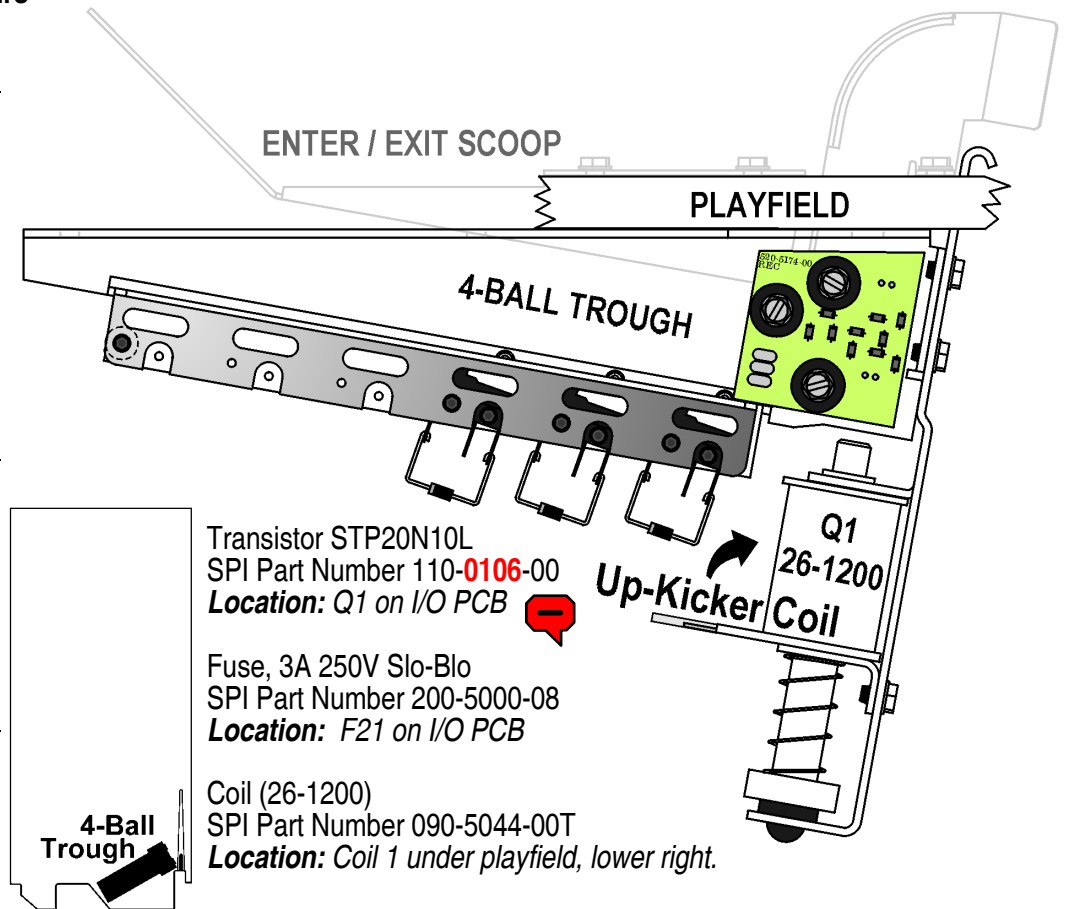
The Game Software Version **4.20** or lower (U210 on the CPU/Sound Board II) has a problem in which it may repetitively fire the Trough Up-Kicker Coil when serving the ball up to the Shooter Lane.

Ensure your Game Code on your CPU/Sound Board in location U210 is **v4.50+** and replace all faulty components.

If you do not have an ePROM Burner, you'll need to order the latest version on an EPROM from your local distributor. Ask for SPI Part Number 960-5009-00 and specify if you need Grand Prix or NASCAR Game Code.
