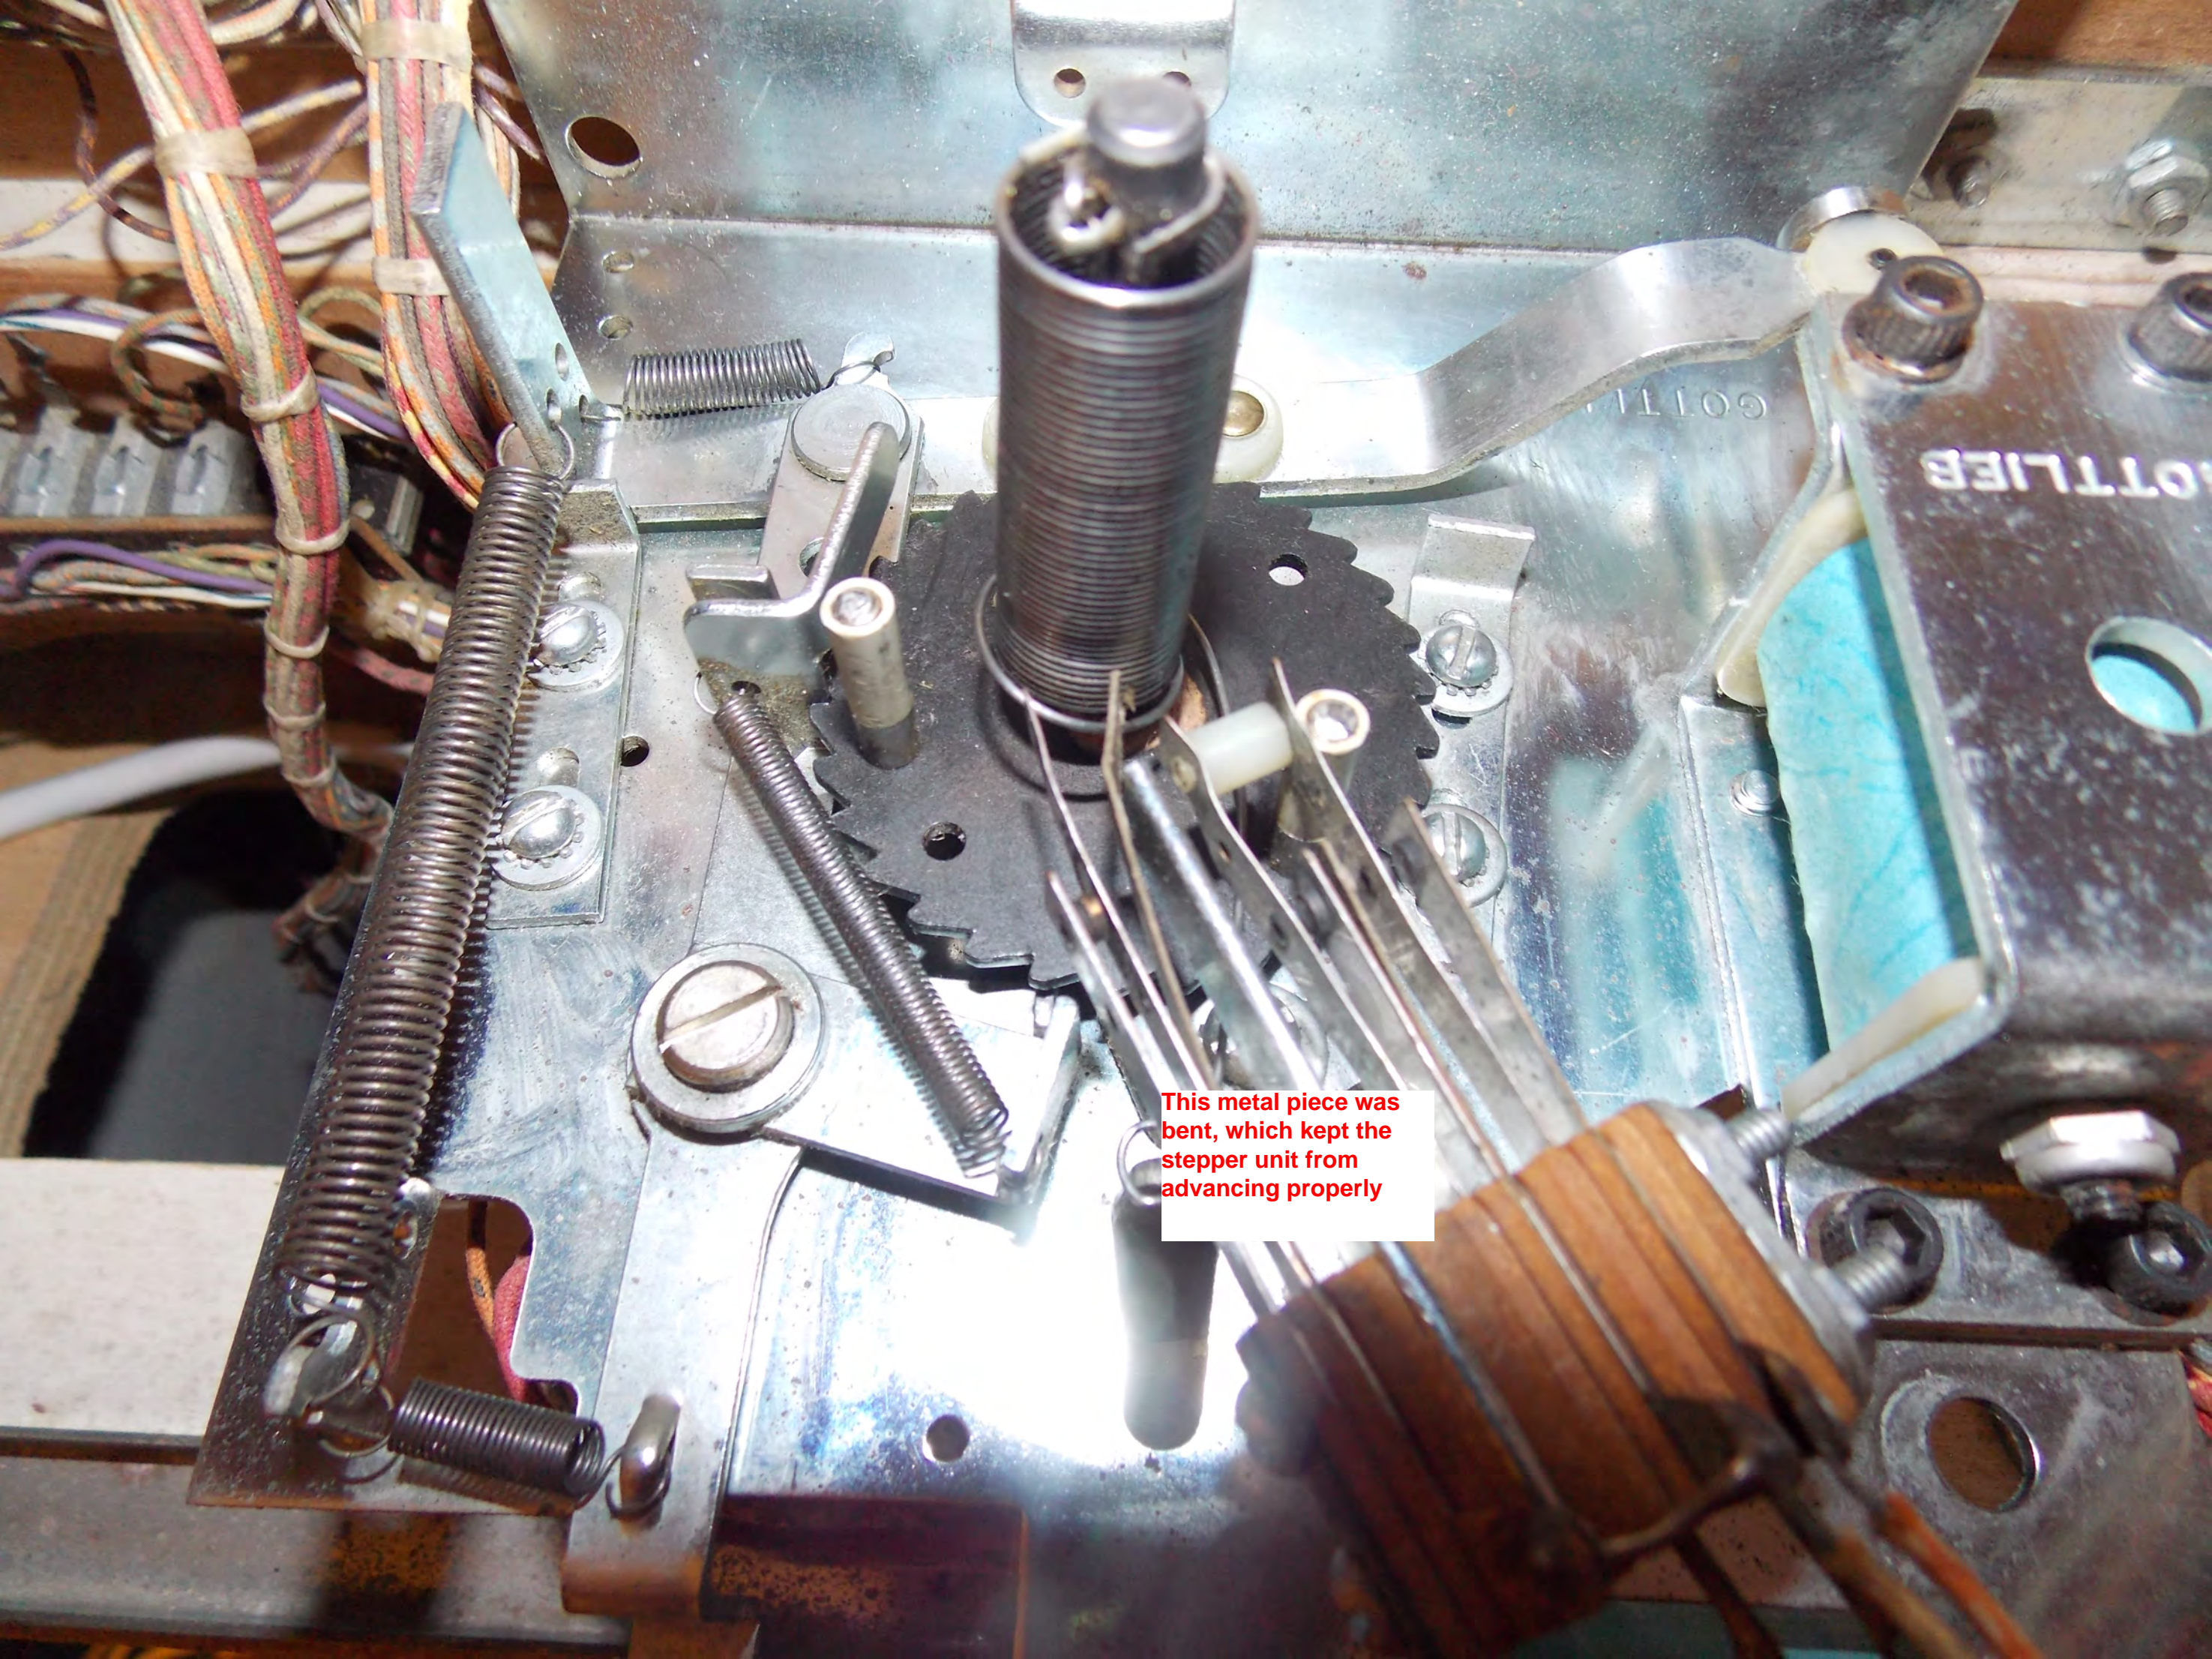
This metal piece was bent, which kept the stepper unit from advancing properly
