# Service Bulletin: SB 50

**GAME:** Whitewater

**SUBJECT:** Intermittent or weak action from ball popper assembly A-15769

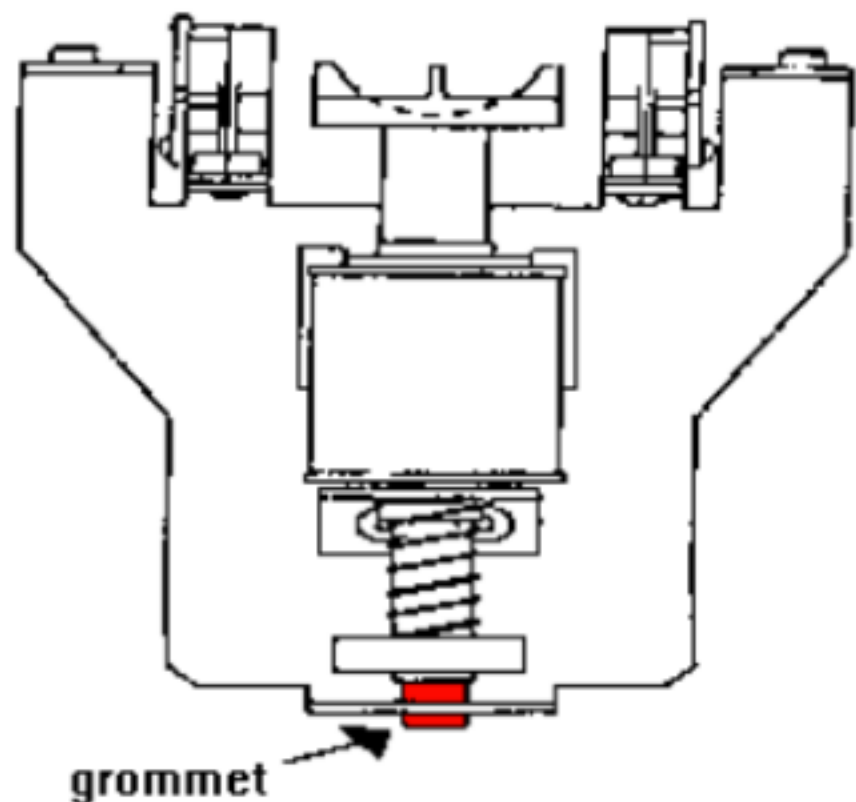
**CAUSE:** Rubber Grommet missing or installed incorrectly on ball popper assembly

We have had a few customers reporting that the rubber grommet (part #23-6420) on the ball popper assembly of "Whitewater" pinballs have been missing. See the diagram below for the location of the grommet. Please check your game and install a new grommet if needed.
