## TAF Slide Out Playfied Conversion

my install per pinside user: pfinny 3/29/21

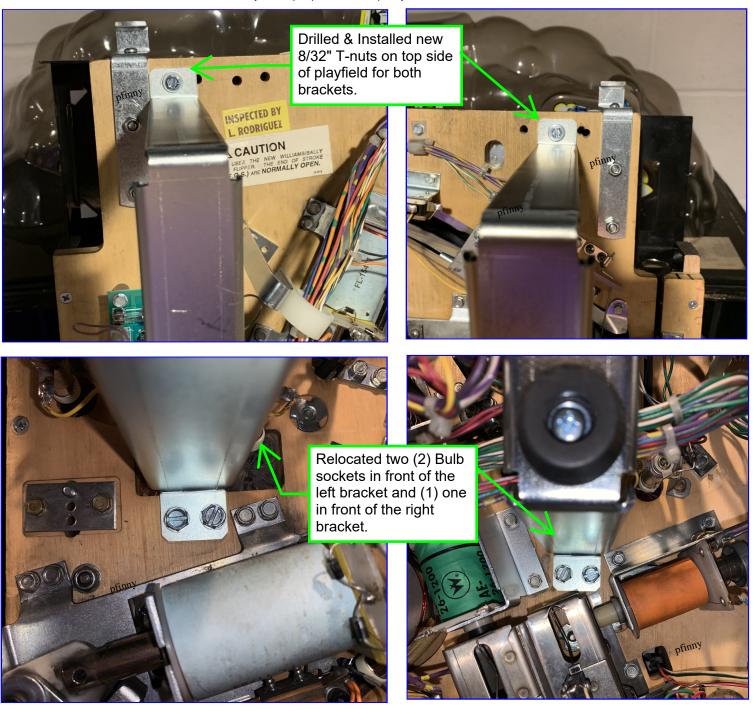
Four of the wiring harness standoffs were too tall after installing the new Stern style playfield support brackets and needed to be lowered.

Instead of buying new or cutting off and redrilling holes I just bent them over as shown and used the existing hole to remount the cable clamps.
